ROADS & BRIDGES

WEB EXCLUSIVE

A bridge between agencies

Fork it over

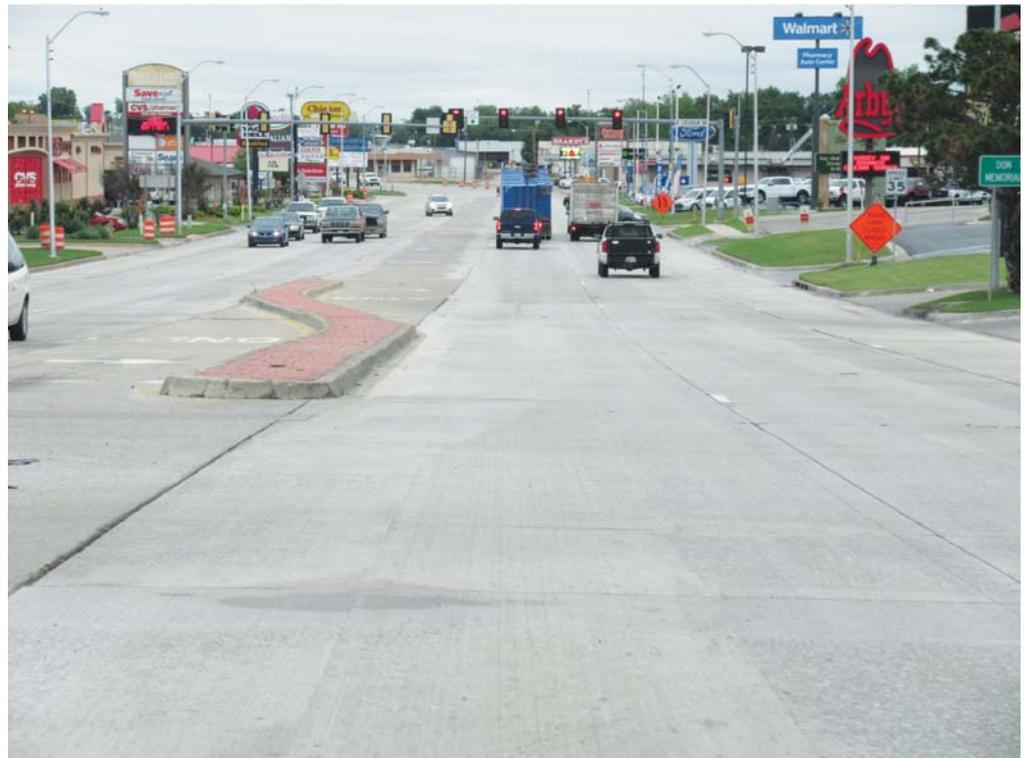
Full-depth repairs were made to approximately 17,500 sq yd of roadway in the Chickasha, Okla., area.

Interstate Improvement Inc., based in Faribault, Minn., began constructing full-depth repairs last fall. Full-depth repairs were necessary in the areas where pavement distresses extended through the entire depth of pavement. "Interstate Improvement repaired about 17,500 sq yd of the approximate 100,000 sq yd of the roadway in the Chickasha area," said Sam Gramling, president and chief operations officer of Interstate Improvement.

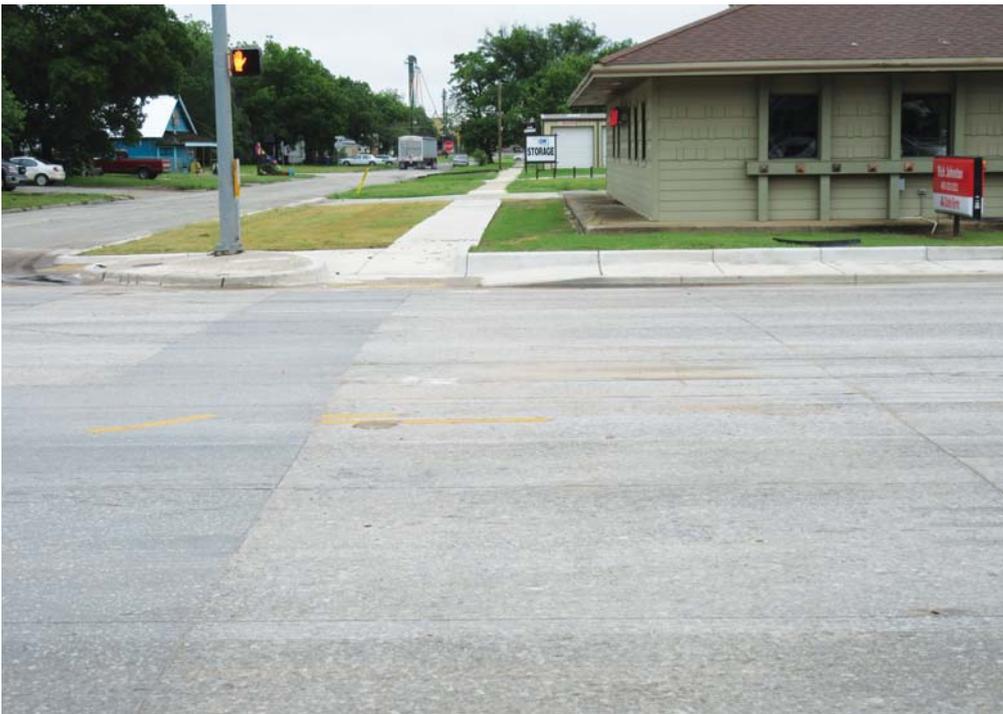
Under the U.S. 81 contract in Oklahoma, crews also made curb and gutter repairs, as well as sidewalk repairs. New construction including two new turn lanes, pedestrian ramps and sidewalks at eight intersections also was required under the new contract.

Curb and gutter repair, as well as sidewalk repair, were completed by the same crew tasked with the concrete patching. In order to be time-efficient, the crew accomplished the additional repairs while waiting to achieve opening strength on the roadway repairs—making use of what would otherwise have been downtime.

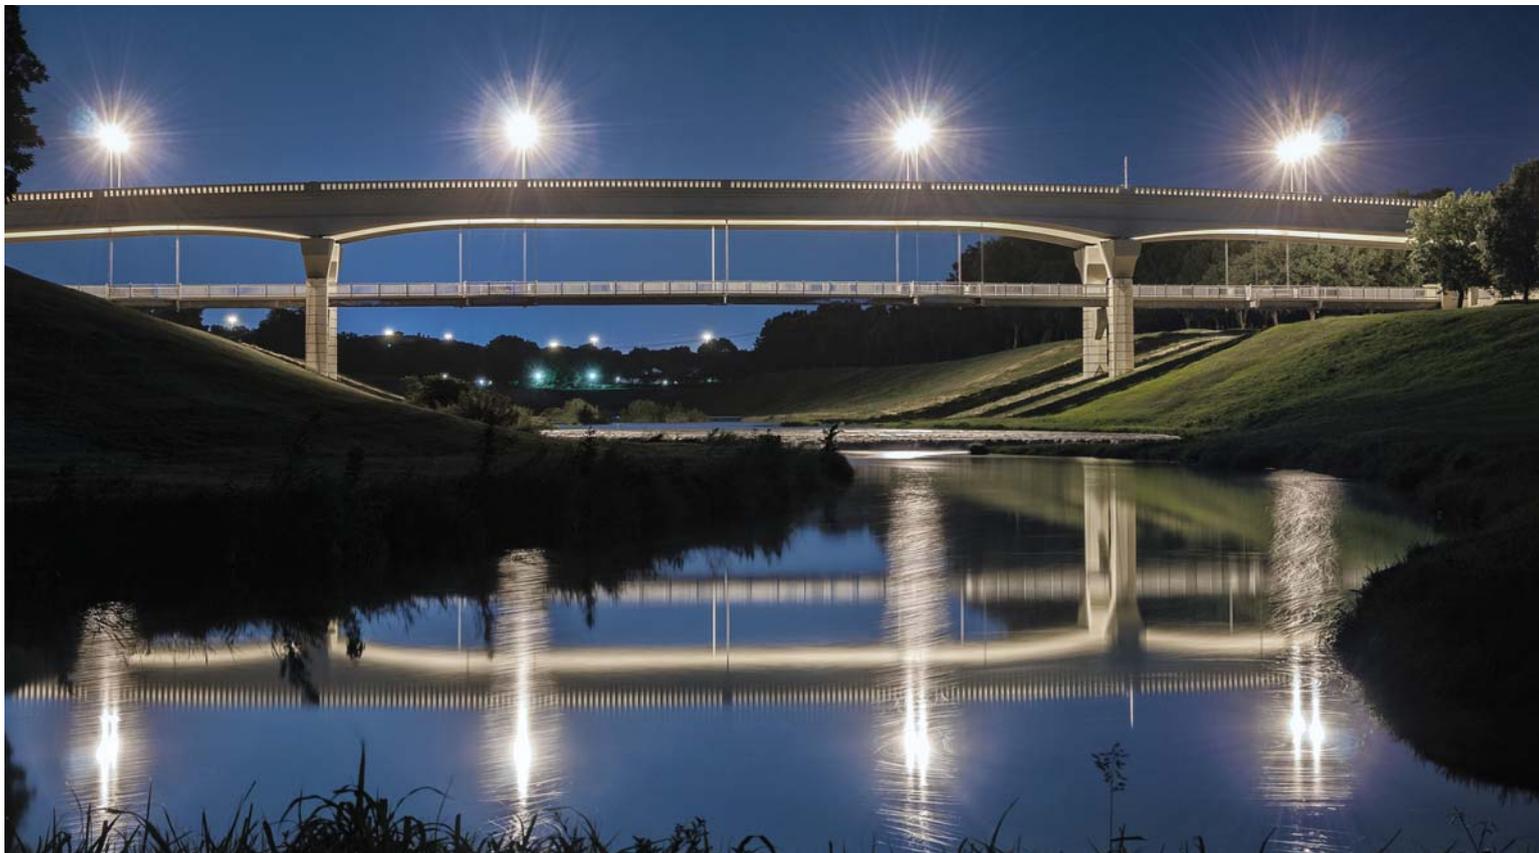
There are only two sets of piers on the riverbanks supporting the 550-ft bridge, which lessens environmental impact.

This 550-ft twin precast concrete spliced girder bridge is upheld by only two sets of piers, minimizing environmental impact and falling in line with USACE floodplain strictures.

The design team responded with twin precast concrete spliced girder two-lane vehicular bridges with a steel pedestrian bridge suspended below. There are only two sets of piers on the riverbanks supporting the 550-ft bridge, which lessens environmental impact and allows the structure to meet the stringent USACE requirements for the river and floodplain.

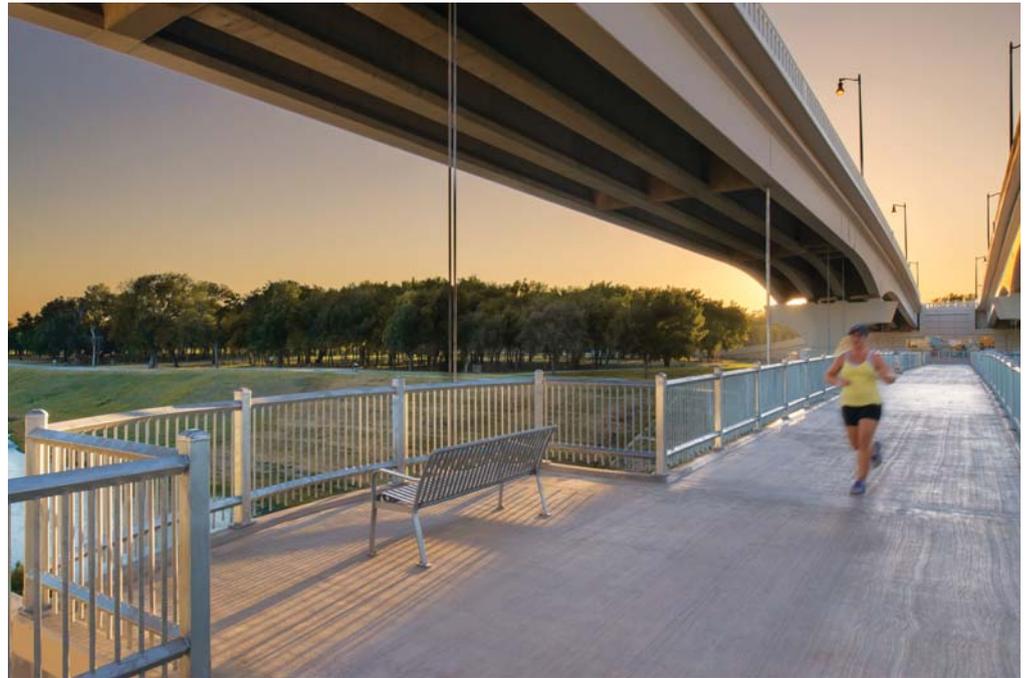
The twin bridges separated by 20 ft were used to allow sunlight to shine through to pedestrians below, thus avoiding a dark, uninviting area that a wider single structure would create.

Twin bridges, separated by a distance of 20 ft, were used to allow sunlight to shine through to pedestrians below, thus avoiding a dark, uninviting area that a wider single structure would create. Each of the twin vehicular bridges has three spans totaling 550 ft, with center spans of 220 ft and end spans of 165 ft.

The split vehicular twin bridges above allow sunlight to naturally illuminate the pedestrian areas below. At night, the vehicular bridge lighting, mounted to the inside vehicular bridge railing, simultaneously illuminates the pedestrian bridge below, creating a pleasant, indirect glow for pedestrians. This also saved money by eliminating pedestrian bridge lighting.

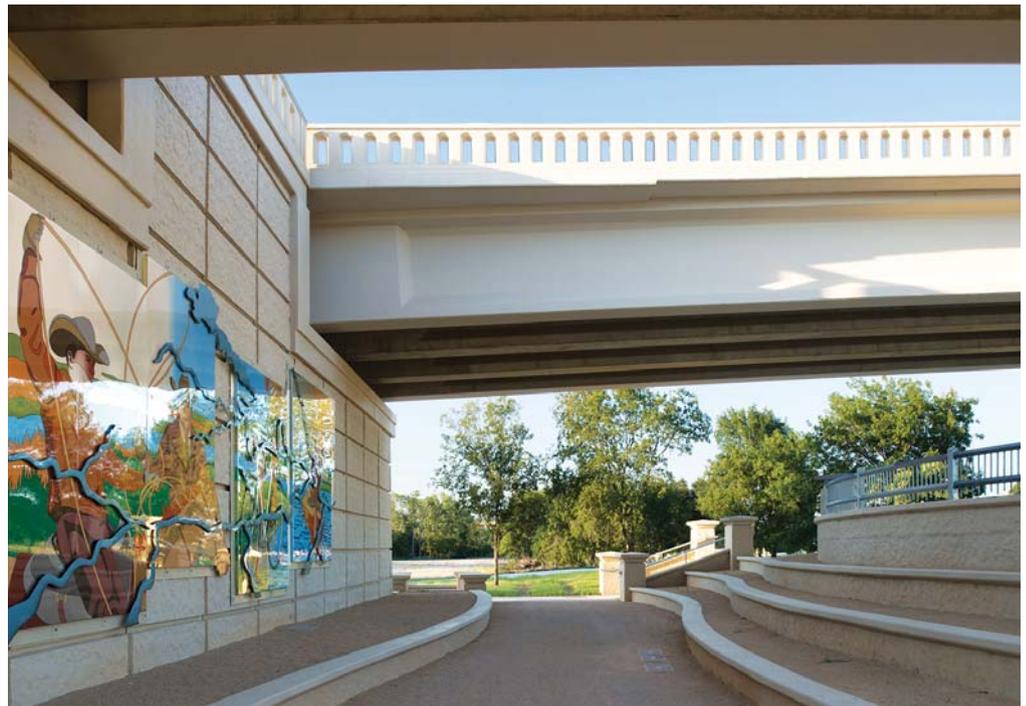
The bridge abutments act as a kind of canvas, shielding pedestrians near the multimodal trail connections and tiered seat walls. These areas have already seen use for social events.

At each end of the pedestrian bridge, near the vehicular bridge abutments, the team designed plaza areas that serve as multimodal trail connections with tiered seat walls offering a shaded rest area for pedestrians and cyclists. The bridge abutments act as a canvas for large-scale public artworks measuring 30 ft wide. These plazas, with their shaded seating and attractive public art, transform what is normally a neglected space to one that is a pedestrian refuge. In fact, these plaza areas have already hosted parties and even been planned for a wedding.

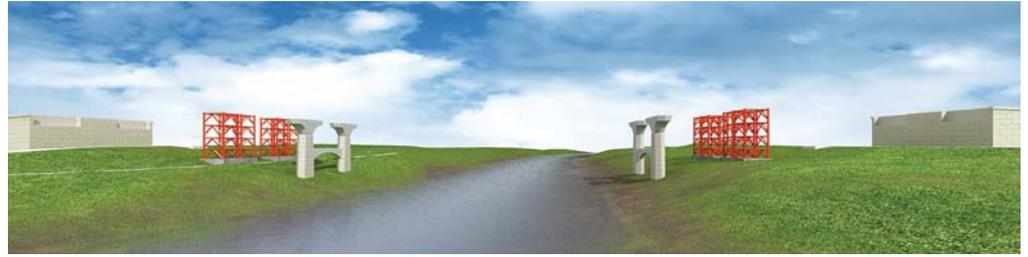
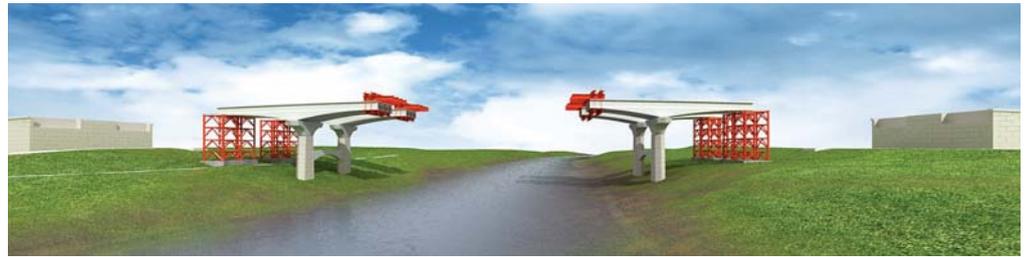
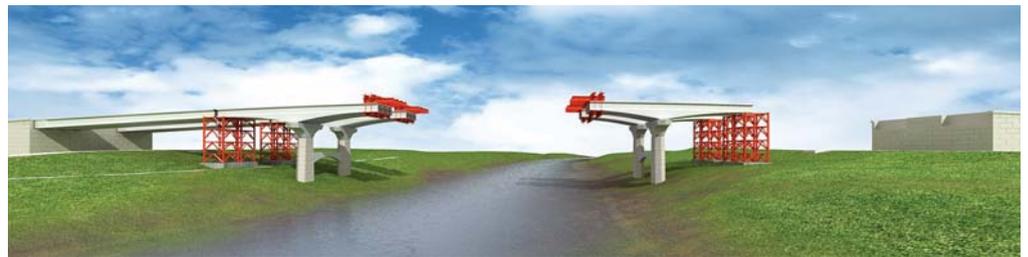
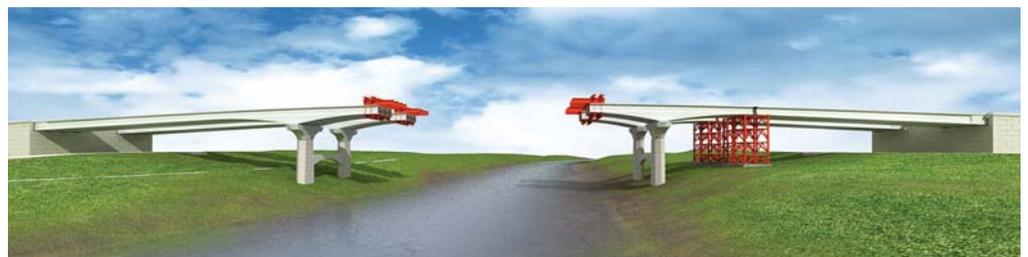
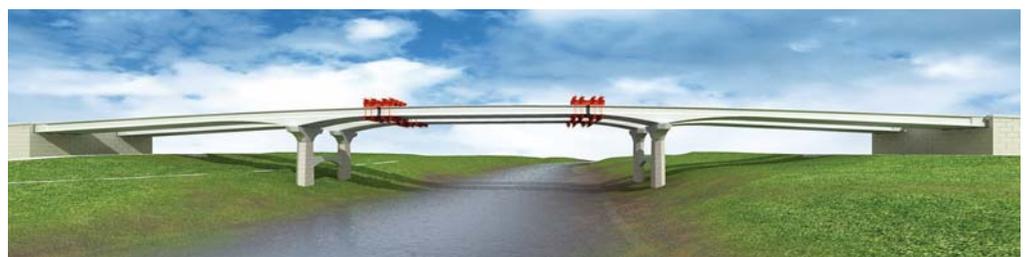
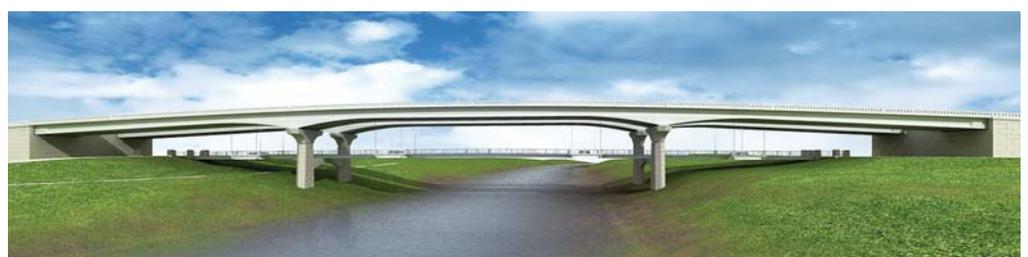
The five prestressed concrete girder segments were spliced together to form one continuous three-span girder, which minimized the bridge's footprint and kept the levee free, per USACE strictures.

This bridge is composed of five precast, prestressed concrete girder segments, ranging from 96 to 120 ft in length, which

were shipped to the site, erected and then spliced together using steel post-tensioning tendons to form one continuous, three-span girder. The five precast concrete segments are field-spliced together using reinforced concrete closure pours. The girder segments were constructed of readily available AASHTO Type VI precast beam shapes, haunched at the columns for additional strength and reduced live-load deflection.
